LYNN RESERVOIR DAM

MA 01285

PHASE I INSPECTION REPORT NATIONAL DAM INSPECTION PROGRAM

JULY, 1981

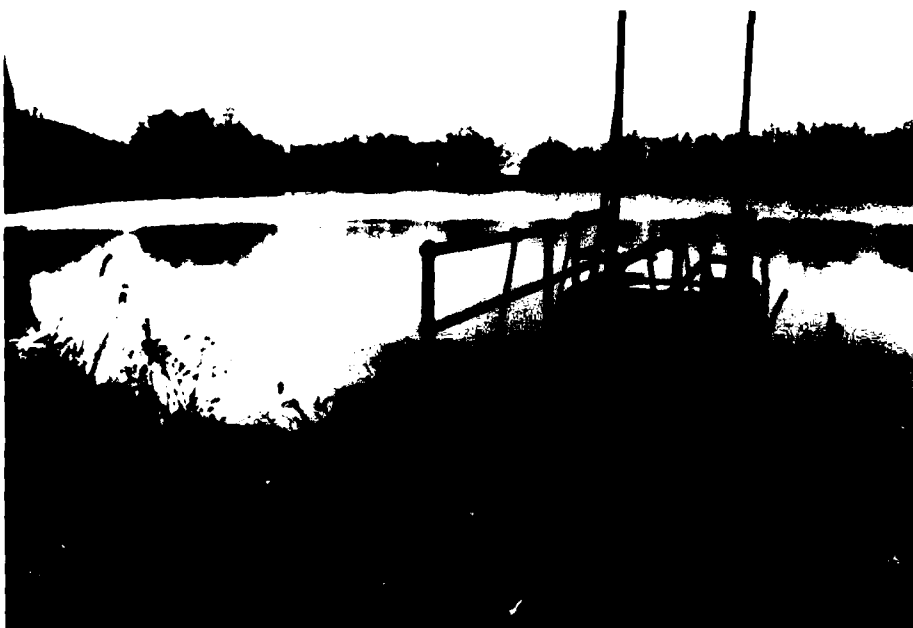
The outlet works (Photo No. 8) consisting of a sluice gate housed in a concrete structure, are near a chlorination building of masonry construction (Photo No. 9). They were reported operable by the owner. The concrete foundation of the service bridge to the outlet works has deteriorated at the water line. The service bridge is in very poor condition (Photo No. 10). The bridge stringers are badly corroded with extensive perforation of the flanges and web. The bridge footing is spalled and cracked (Photo No. 11). The bridge footing on the dam embankment has failed. This footing, of concrete construction, has broken into three distinct parts and is falling into the impoundment. The steel mesh walkway has also deteriorated. Several parts of the mesh have broken and are weakening the rest of the walkway.

The inlet control building shows no sign of instability. The outlet control building is in poor condition with a deteriorating concrete foundation. The access bridge to the outlet control building is also in poor condition and is not structurally sound.

Photo No. 8 - Service bridge to the outlet control structure.
